Conococheague Priority Projects Plan

Detailed Assessment Excerpt for StoryMap

2.4 Assessment Summary

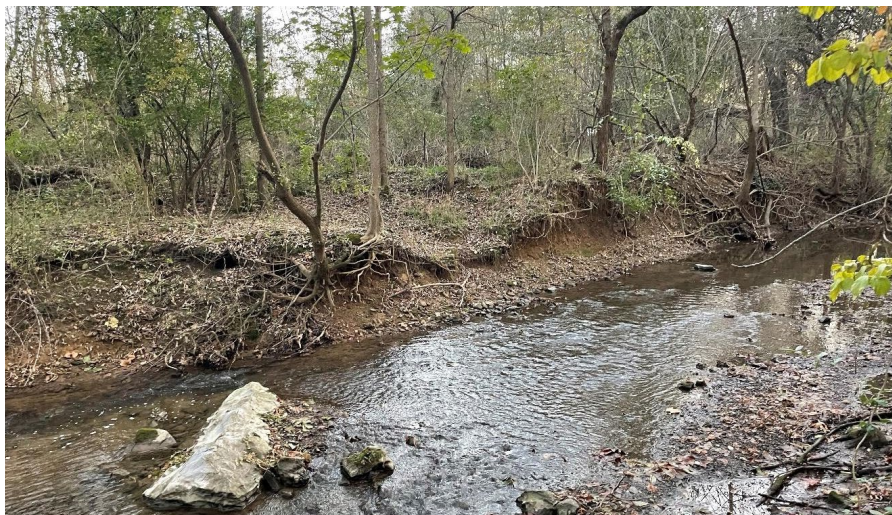
Johnston Run is a tributary to the West Branch Conococheague Creek that is located within the Lower West Branch subwatershed. Most of the headwaters and downstream areas of Johnston Run occur in open agricultural areas, with only the upper-most portions of a few small tributaries originating in forested mountains. The central portion of the stream runs through the town of Mercersburg, which is one of the most densely populated communities in western Franklin County. It is contained within a concrete channel for over 500 feet as it approaches the borough and continues downstream of Main Street. Johnston Run has high vertical banks throughout the areas upstream of Mercersburg. These conditions persist downstream of the urbanized areas and appear to be the result of historic stream manipulation and legacy sediment accumulation. Additionally, current agricultural activity, confinement from existing infrastructure (i.e. roadways, utilities) and urban stormwater runoff are likely contributing to the sediment, nutrient, and pathogens impairments that the Pennsylvania Department of Environmental Protection (PADEP) has identified along the stream. Mercersburg Borough has the Johnston Run Watershed Management Plan prepared in 2014. The plan identifies channel erosion as the source of more than 50% of the total suspended sediment loading in the watershed.

Figure 1: Johnston Run - Eroded Banks as Seen from Walking Trail

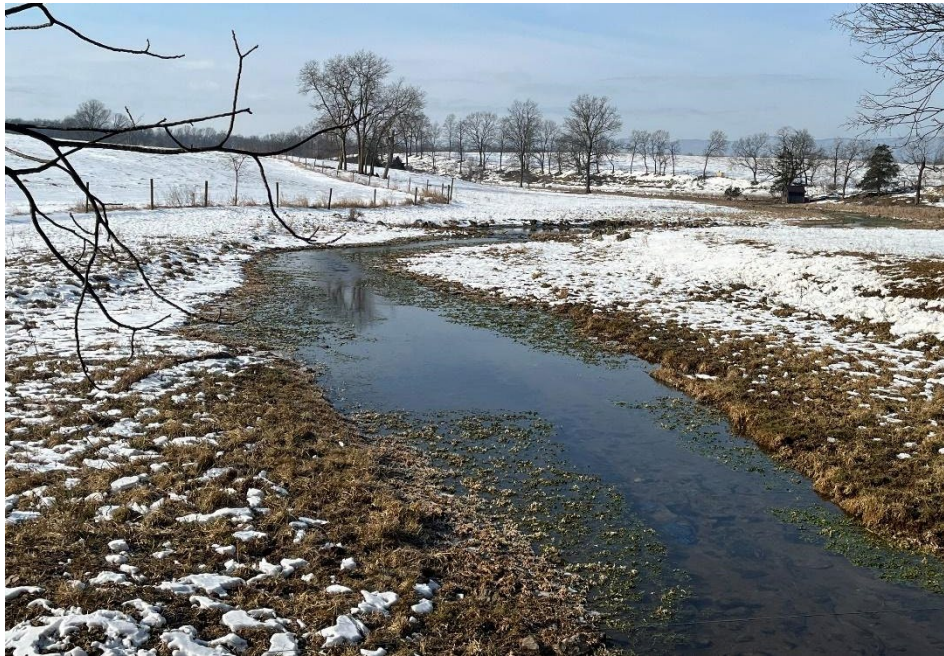
Figure 2: Unnamed Tributary to West Branch Conococheague Creek – Opportunities for a Buffer and Animal Exclusion Fencing in a Small-Scale Catchment

Within the Middle West Branch Conococheague Creek, the small first order headwater streams typically flow from the forested hillsides. PADEP does not identify these streams as impaired and the majority of these reaches appeared to be fairly stable during the visual assessment, despite minimal vegetated riparian buffers and livestock exclusion fencing. These practices would improve floodplain ecology and achieve pollutant load reductions.

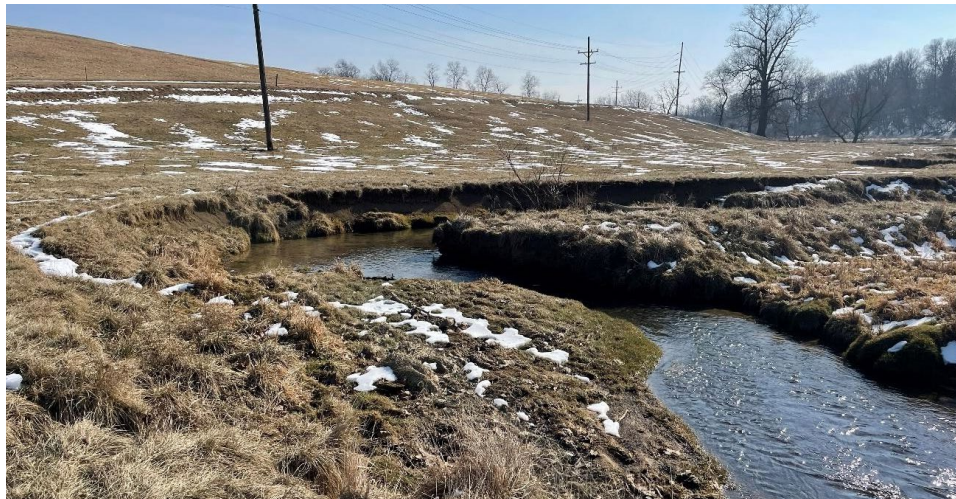
The Campbell Run-Back Creek HUC12 subwatershed contains mostly flat, open, valley areas that are mostly utilized for agriculture. Campbell Run consists of 1st, 2nd, and 3rd order streams of varying stability. The 1st order streams appear relatively stable with minimal incision or erosion. There are some narrow riparian buffers in these small-scale catchments, but there is opportunity for improvement through buffers and livestock exclusion. Transitioning to the mid-scale watershed, mild to moderate bank erosion can be seen in outside meander bends of in the 2nd and 3rd order streams. Downstream of Lincoln Highway West, these conditions worsen as three branches come together in a forested area. In this watershed, severe bank erosion is observed throughout the channel's unstable meanders. The 3'-4' bank heights are mostly vertical or undercut and slumping. This condition, resulting from extensive legacy sediment impairments, persists downstream to the confluence with Back Creek. The overbank conditions and land uses speed up erosion rates. The land use is primarily grazing pasture or hay meadow, while some parcels are row cropped through the floodplain. Most of the reach does not currently have riparian buffers or exclusion fencing. Where buffers do exist, they are relatively thin and often limited to one side of the channel. These buffers are not able to entirely address erosive conditions as the trees are perched upon legacy sediments. In several locations, fence rows were undercut or there were fence posts falling into the stream due to bank erosion and lateral migration. Floodplain restoration practices are feasible throughout much of this reach and would serve to achieve substantial nutrient load reductions through eliminating onsite erosion and restoring nutrient-processing floodplain wetlands to mitigate incoming pollutants and allow sediment to settle before the water reenters the stream system.

Figure 3: Eroded streambanks along Campbells Run downstream of Pioneer Drive

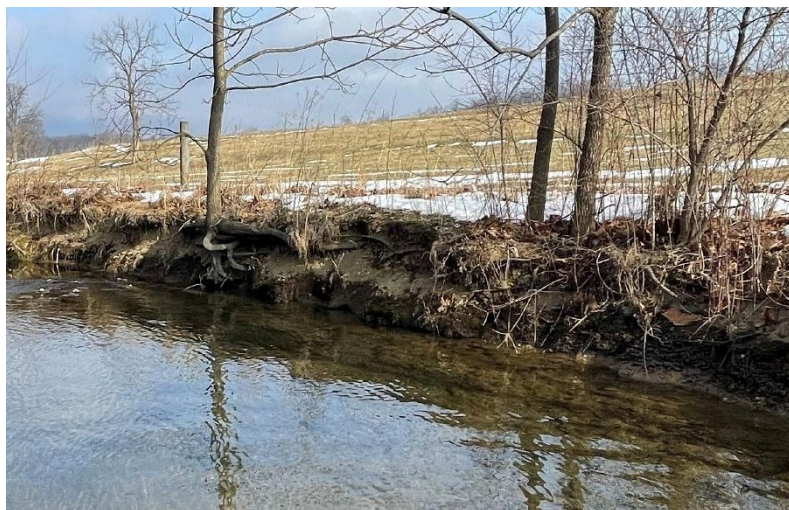
sedimentation and it loses its wild trout population. While there are many reaches with little or no riparian buffer, forested buffers become more prevalent near the confluence with Back Creek compared to other watersheds assessed. In the small catchments upstream in the watershed, there is some mild bank erosion in specific locations, but most banks are relatively stable and vegetated. There are more buffers and exclusion fences present than in most of the other sub-watersheds, but there are certainly opportunities for more. In a downstream section of Dennis Creek, the stream is evident legacy sediment accumulation with vertical eroding banks up to 4' high in outside meander bends. Exclusion fencing and a forested riparian buffer are present, but not effective enough at this scale to address the primary source of pollutant loading (bank erosion), as evident by the undercut trees and fenceposts. The condition persists well downstream where the channel enters an unassessed forested area.

Figure 4: Eroding Banks and Undercut Buffer Plantings on Wilson Run

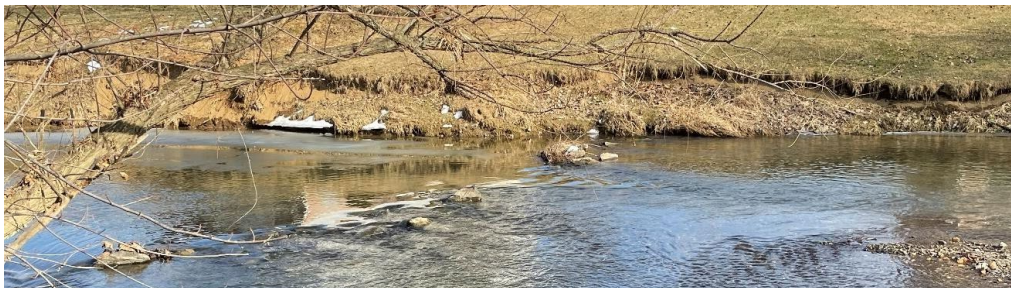
The mainstem of Back Creek exhibited similar channel incision and floodplain disconnection observed in many of the contributing systems. The mainstem is more subject to infrastructure encroachments from utilities, roads, bridges, and buildings. Some portions of Back Creek have become over-widened to a point of arrested degradation where the widened channel reduces flow energy and erosion rates enough to support vegetation. At these locations the banks are relatively stable compared to the tributary reaches, but ecological function remains impaired due to the persisting floodplain disconnection. There are still long reaches of Back Creek with substantial erosion, and in these areas, the erosive conditions can be more problematic than the smaller tributaries in terms of threats to existing development. Excessive erosion is present immediately downstream of Route 30. This reach passes through a residential area, resulting in property loss along several residential yards. This reach is on the boundary of Hamilton and St. Thomas Townships and is within the urbanized area. Further upstream, severe bank erosion occurs where the channel parallels the Hamilton Ruritan Grounds upstream of Edenville Road. Throughout this reach and continuing to the Fort McCord Road crossing bank heights range from 4.5' to 6'. Looking upstream from Fort McCord Road towards the confluence with Rocky Spring Branch, the unconfined floodplain is maintained as grazing pasture with no buffer or livestock exclusion fencing. The channel is incised within legacy sediments, with bank erosion occurring along all banks. This reach would be suitable for floodplain restoration and wetland creation practices.

Figure 13: Bank erosion along Back Creek downstream of Route 30

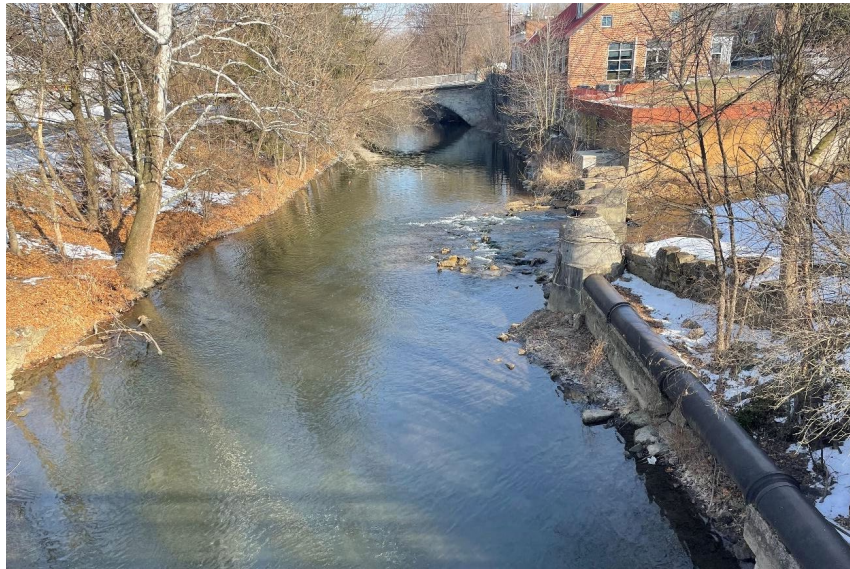
Figure 14: Confluence of Falling Spring Branch at the Conococheague Creek

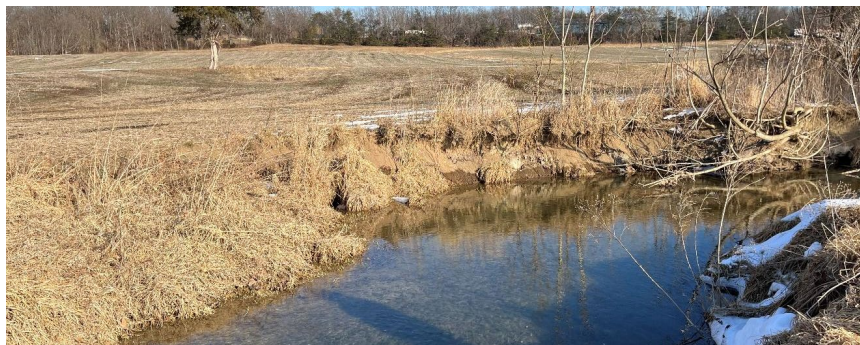
Figure 15: Muddy Run - Open Agricultural Area with Eroded Banks

The Muddy Run HUC12 subwatershed consists of predominantly agricultural areas in Antrim Township; however, there are urban and suburban areas towards the downstream portions of the watershed in and around Greencastle Borough. Many of the headwaters are within relatively flat open areas with limited buffer vegetation. Within the middle and large-scale watershed areas, many of the streams show evidence of moderate to severe erosion.
