Banta Property Floodplain Restoration

Water Quality | Flooding Issues

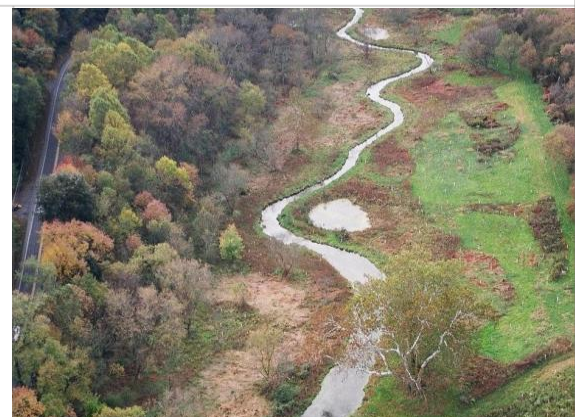
After

LandStudies restored 2,250 linear feet of stream and floodplain which included relocating the channel back to the center of the valley, at the lowest elevation. Cross vanes and rock vanes were installed specifically to improve trout habitat. Today, the restored channel meanders through the middle of the valley. The floodplain rises only a short distance above the surface of the water, and wetlands are frequent along the length of the restored channel. The restoration site was planted with a thriving native plant community, however, volunteer native flowering plants are also appearing. The original seed bank, which had, for centuries, been covered by legacy sediments, is once again near the surface, and the dormant seeds have begun to germinate and grow.

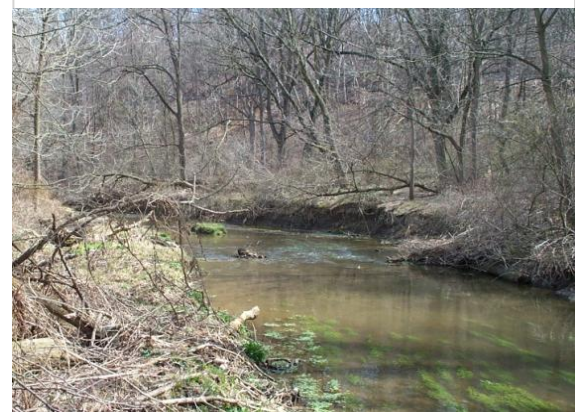
Before

The section of Lititz Run that flows through the Banta property historically had been dammed for a mill operation as well as moved and straightened. This disturbance caused instability typical of most streams in Lancaster County. The channel was eroding both downward and laterally, creating an overly wide and deep channel.
