Big Spring Run

Stream and Floodplain Restoration

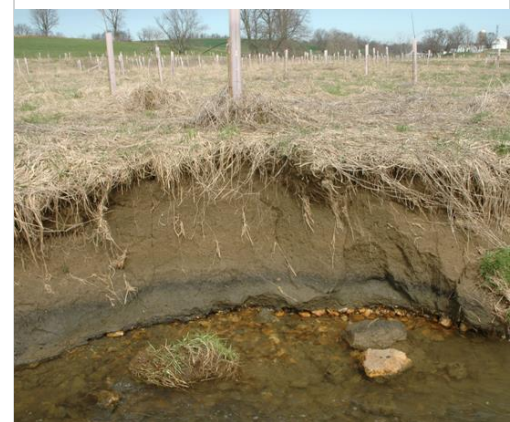
Before

The Big Spring Run tributary is a headwater system that has been impacted by historical human activities. Big Spring Run became characterized by severe streambank erosion and stream bed degradation, with the nutrient-rich sediment released through these erosional processes affecting downstream water quality.
