# Bedford Springs Resort

## Stream and Floodplain Restoration

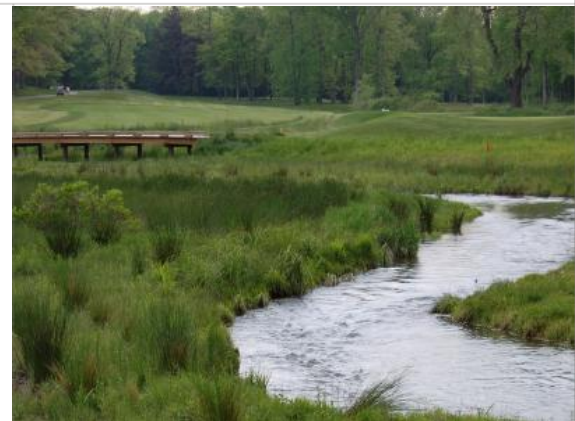
After

LandStudies, Inc. designed and constructed a restoration project restoring approximately 6,800 linear feet of Shoher's Run. The floodplain was excavated to its historic elevation and an 80-foot minimum floodplain corridor was provided to allow high flows to access the floodplain, reducing shear stress on the bed and banks and providing flood storage during storm events. In-stream structures were installed in the channel to provide grade control, bank protection, and improve aquatic habitat. 12 acres of wetlands were also created as a result of the restoration.

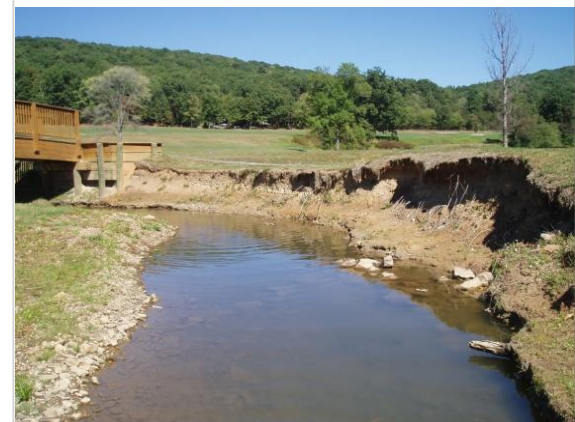
The golf course associated with the historic Bedford Springs Resort was still in use, but many of the course features were being threatened by flooding and erosion along Shoher's Run. The site contributed to non-point source pollution, and large storm events accelerated streambed and bank erosion and promoted bank failures of the existing vertical banks.

Before
