TPC Potomac at Avenel Farm

Stream and Floodplain Restoration

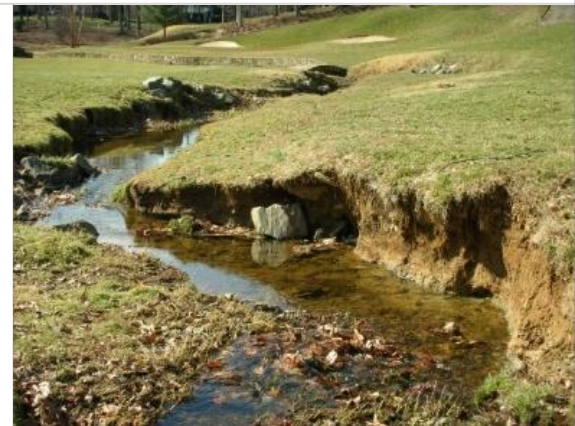
Before

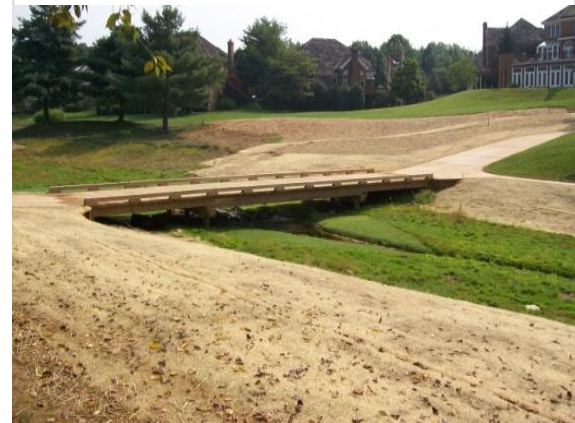
During Construction
