# Lititz Run at Oak Street

## Floodplain Wetland Restoration

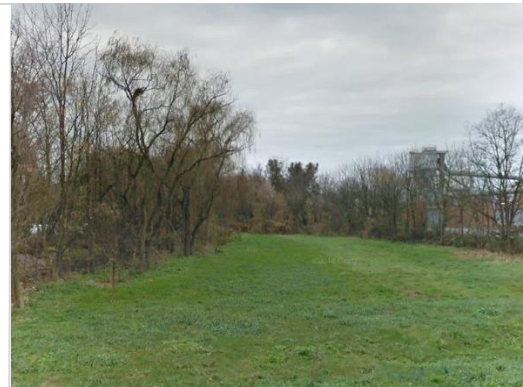
Before restoration

The project along the Lititz Run in the Borough of Lititz has been affected by historic human activity including mill operations, channel straightening, and road and bridge construction, which have led to the alteration and degradation of the stream as well as legacy sediment deposition. The project reach was incised, over-wide in spots, and disconnected from its floodplain. Bankfull and higher flows were contained within its steep, vertical banks and could not regularly access the active floodplain, resulting in accelerated bank erosion, ineffective flood conveyance storage, and streambank instability.

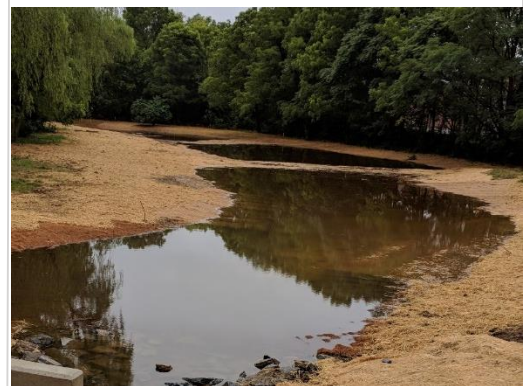
After – post-construction flood event

Through a DEP Local Stormwater BMP Implementation Grant administered by the Borough of Lititz, LandStudies designed a 0.75-acre low wetland area to reduce pressure on the streambanks and to treat stormwater run-off from the watershed, which functions by filtering flood flows from the surrounding urban areas and watershed. The wetland is planted with native plants that increase biodiversity and create wildlife habitat while improving water quality. Many of the existing trees were preserved and additional trees were added, increasing the riparian buffer benefits for Lititz Run. Neighbors have commented on the diversity of flowers and beauty of this site during the spring and summer months. To help educate the community about the benefits of this restoration, educational signs and an ADA accessible pathway have been installed.
